DURABILITY TEST

TEST ŽIVOTNOSTI: oplet – nerezová ocel 201CU, spirála – nerezová ocel 202

TEST ŽIVOTNOSTI: oplet – nerezová ocel 304, spirála – nerezová ocel 304

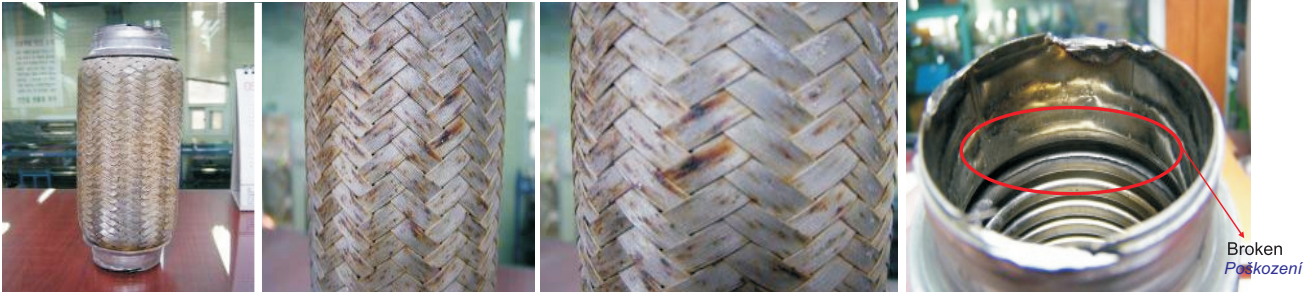
Test	2007.05.8~9	Size:	Ø51.3×170
Buyer	STS Braid 201CU + 202 Coil RE-TEST	Type	OB
TEST		Corrugation	18EA
SPEC Standard :300,000 cycle Frequency : 10Hz Displacement : ±10.7(180mm) Temperature : 500°C Cooling Time : 10 sec		Test Condition Life cycle :150.000 cycle Frequency : 11Hz ~ 12.5Hz Displacement : ±11 Temperature : 600°C~700°C Cooling time :60sec heat-10 sec cooling

Result	<i>Výsledek</i>	Decision	<i>Rozhodnutí</i>
<ul style="list-style-type: none"> Severe Rust happened as 1st test <i>Rez se objevila při první testu</i> 1st Corrugation was broken at 15,000 cycle <i>Zvlněná trubka byla rozlomena při 15000 cyklu</i> 		201CU Braid + 202 Coil - Not usable <i>Pletenec není použitelný</i>
